Corrosion Report

Equipment Location ID 0955-009-001
Equip. Location Descrip. C-1100 OUTLET- BOTTOMS TO P-1105/A

INSPECTION PIPING ISOMETRIC

#4 CRUDE UNIT (PLANT 11)

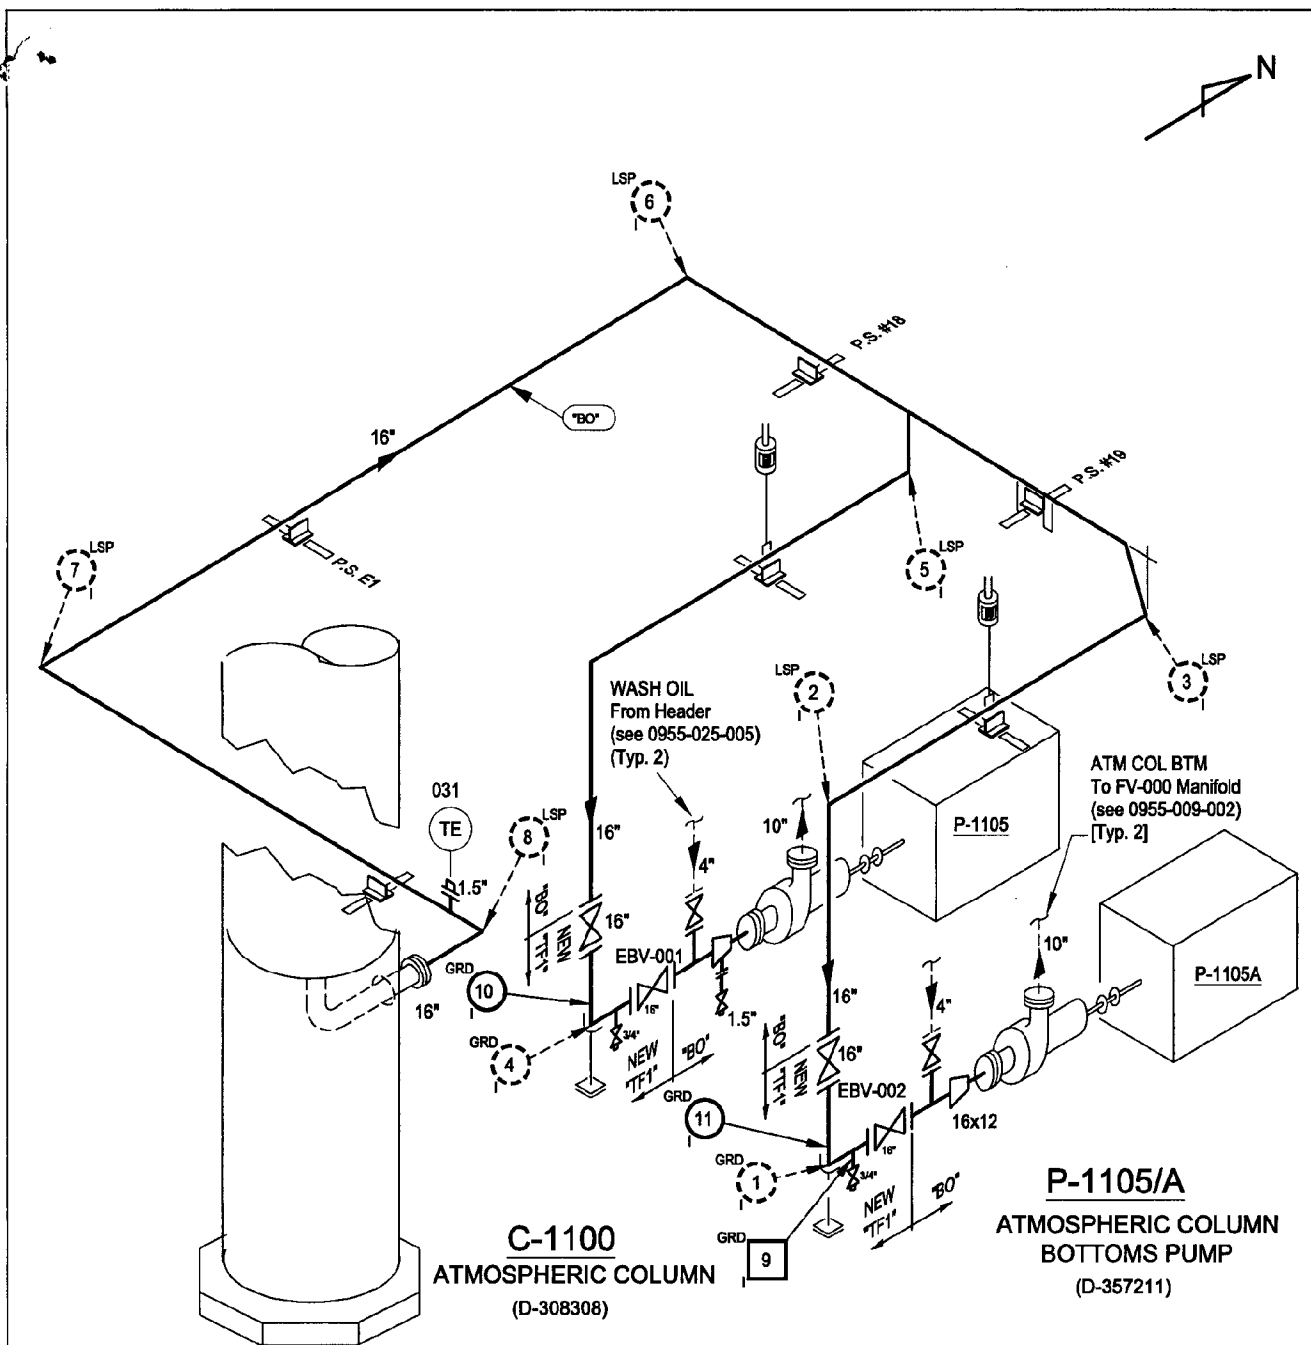
0955-009-001

DP ID	MEAS METH	DP STAT	DP SZ	DT TYPE	BASE	MEAS 5	MEAS 4	MEAS 3	NEAR	LAST	MIN VALUE	CCR	REM LIFE
009.R	RT	A	0.75	NIP	0.210 12/02					0.210 11/11	0.100	0.00	∞
010.E	UT	A	16.00	PIPE	0.475 10/02					0.470 11/11	0.296	0.55	315.22
010.N	UT	A	16.00	PIPE	0.516 10/02					0.480 11/11	0.296	3.98	46.29
010.S	UT	A	16.00	PIPE	0.479 10/02					0.480 11/11	0.296	0.00	∞
010.W	UT	A	16.00	PIPE	0.472 10/02					0.480 11/11	0.296	0.00	∞
011.E	UT	A	16.00	PIPE	0.497 10/02					0.490 11/11	0.296	0.77	250.97
011.N	UT	A	16.00	PIPE	0.503 10/02					0.490 11/11	0.296	1.44	135.19
011.S	UT	A	16.00	PIPE	0.502 10/02					0.490 11/11	0.296	1.33	146.42
011.W	UT	A	16.00	PIPE	0.496 10/02					0.490 11/11	0.296	0.66	293.05

**THIS IS A HOT CIRCUIT.
GAGE ON SHUTDOWN ONLY.**
